## Safety Camera Personal Injury Collision Data

| Safety Camera Location: Stuart Street near Wellington Street | |
| Site Number: T 15 Fixed site | Camera coordinates: 508772, 221279 |

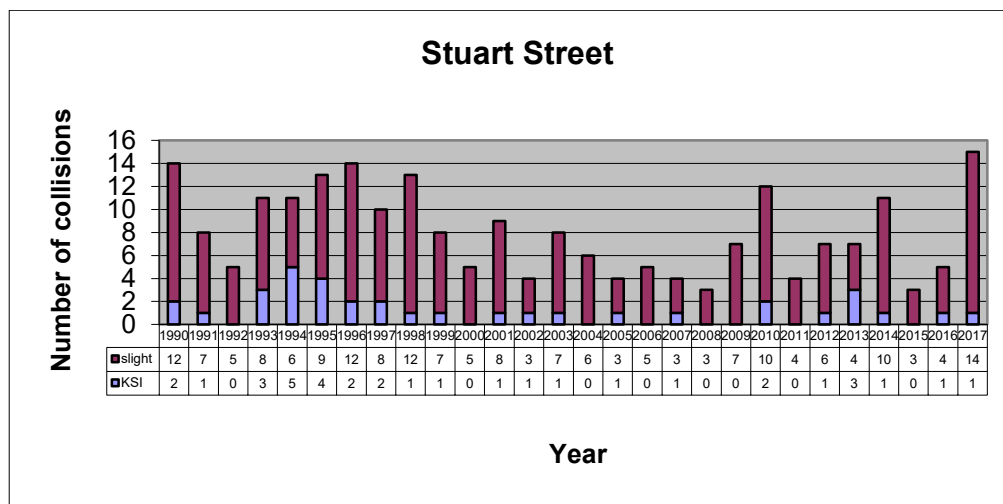
## Collision and casualty information:
