## Safety Camera Personal Injury Collision Data

| Safety Camera Location: Toddington Rd near Montague Avenue | |
| Site Number: T26/T27 Fixed site | Camera coordinates: 505205, 224726 |

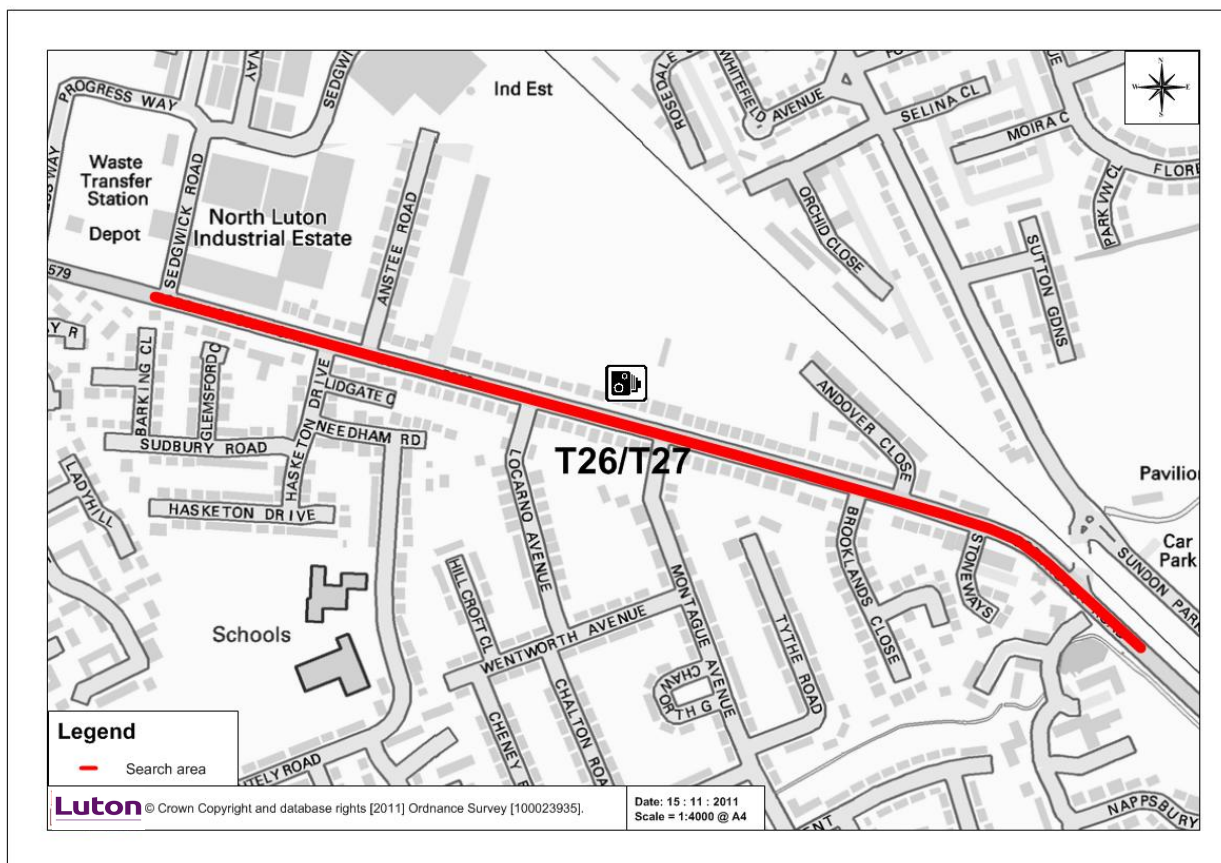
Plan of site including search area:
