# Safety Camera Personal Injury Collision Data

## Safety Camera Location: Crawley Green Road

| Site Number: T11/T12 Fixed site | Camera coordinates: 510130, 221371 |
| Date established: March 1998 | Speed Limit: 30mph |

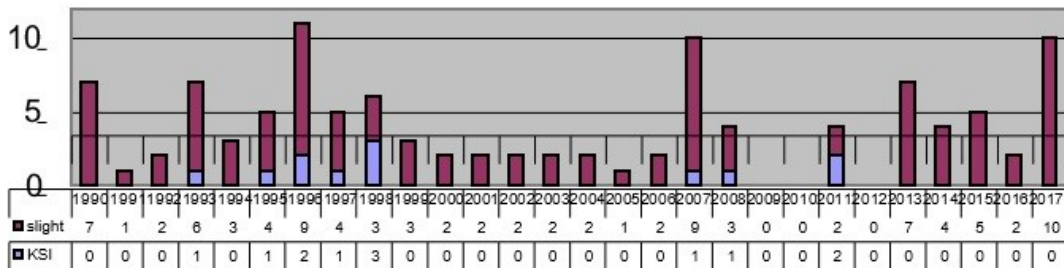
## Crawley Green Road

Number of casualties

Year
