Environmental Protection Act 1990, section 78h(7) (the 1990 act)

Remediation statement prepared by BP Oil UK Limited

This remediation statement is prepared by BP Oil UK Limited in relation to contaminated land identified by Luton Borough Council under s78B of the Environmental Protection Act 1990 (the 1990 Act) and designated as a special site under section 78C of the 1990 Act.

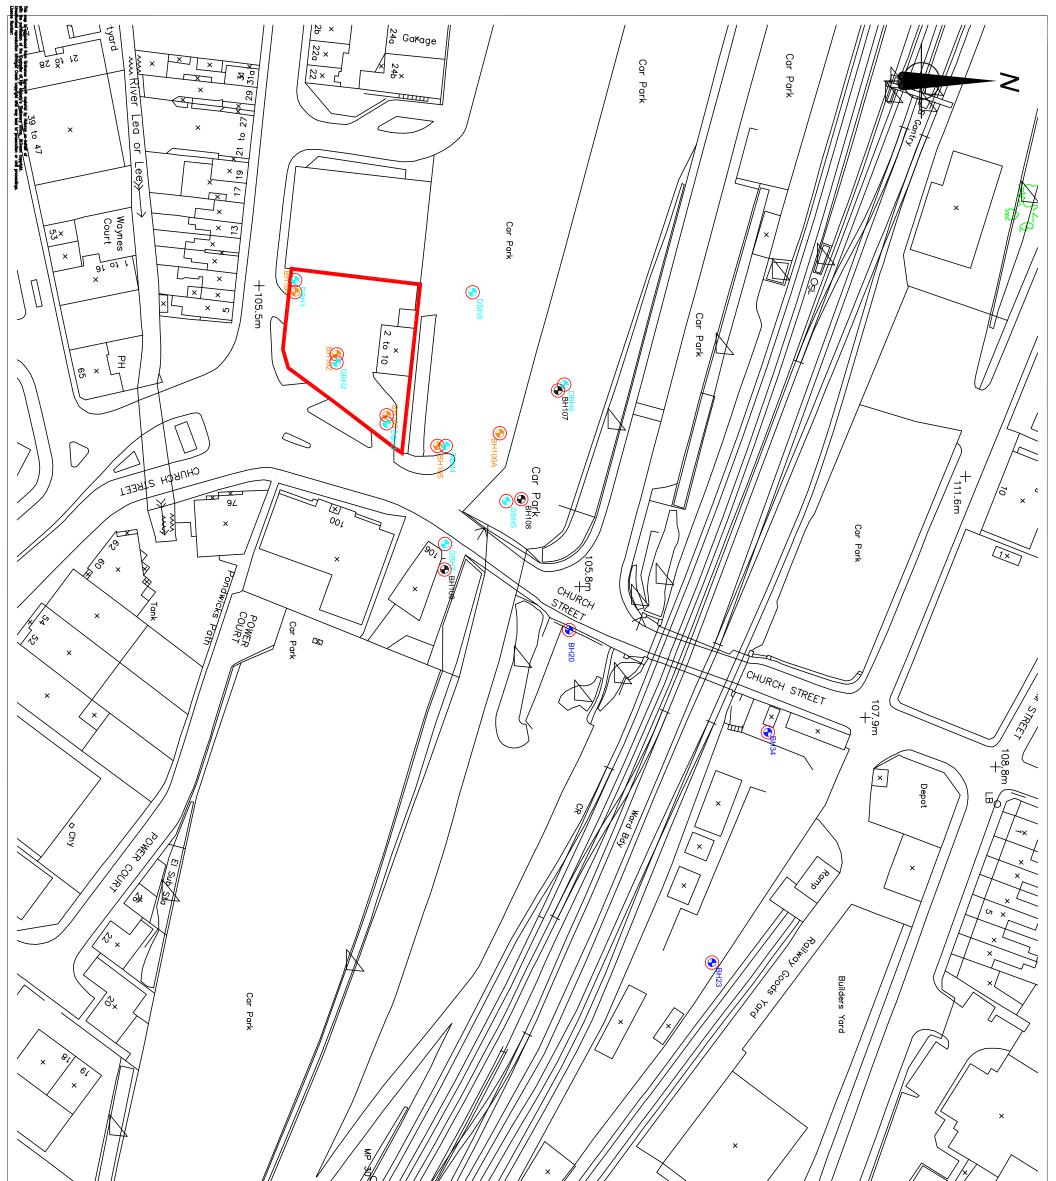
PRELIMINARY							5. XXX >			CRESCENT ROAD	×	×		× //
Drawing Scale: 1:10,000 at A3	Drawn by: RML Date: Oct 10 Checked by - Date: Oct 10 Checked by - Date: Date: Otto: Date: Otto:	RING	Project GUILDFORD STREET,	Harrow Group Limbed Hadrow Group Limbed Tel + 40 (12): 452:855 For - 440 (2):24 (20):80	Rev By Chiel Description		Notes 1. Drawing information taken from the Celtic Drawing No. D1390/3795/A19 (23/03/10)	 Halcrow 2009 (BH107 to BH109) Proposed shallow groundwater monitoring borehole in the Putty Chalk 	 Celtic 2010 (DB1 to DB8) Proposed deep groundwater monitoring boreholes in the Middle Chalk 	 Halcrow June 2009 to June 2010 (BH101 to BH106A) Installation of boreholes to delineate the vertical profile of contamination within the Putty Chalk and associated groundwater 	 Arcadis/Subadra 1999 to 2002 (BH6-BH27, BH29, BH34-BH37) Installation of boreholes to delineate the extent of dissolved and free phase 	 Proposed groundwater sampling boreholes 	Extent of land designated as contaminated land	Key Plan:

Pollutant	Seene of	-	
		Scope of	Date	Location of
	Linkage No.	Action		Action
1	1	Groundwater	August 2010 –	Schedule 1
		quality	February 2012	Figure 6
		Monitoring	,	5
		carried out at		
		monthly		
		intervals from a		
		series of		
		boreholes		
		within the		
		source zone		
		and down		
		gradient of the		
		site. The		
		monitoring to		
		be carried out		
		at monthly		
		intervals over a		
		period of 6		
		months before		
		and during		
		treatment and		
		for 12 months		
		following the		
		achievement of		
		asymptotic		
		conditions		
		within the		
		treatment zone.		
		Analysis to		
		include TPH		
		CWG Aliphatic		
		and Aromatic		
		functions,		
		BTEX, pH and		
		DO. Further		
		monitoring will		
		be scheduled in		
		blocks of 3		
		months of		
		additional		
		monitoring		
		should results		
		indicate that

further monitoring is necessary.		
2		Undertake a pumping switch off trial in accordance with the method statement agreed with the EA and Veolia Water in order to demonstrate that the hydraulic containment system consisting of boreholes BH30, BH32 and BH33 is unnecessary.	January 2011 – February 2011 Contaminant analysis and Level logger monitoring until June 2011	Schedule 1 Figure 6
3	1	Undertake a pumping switch off trial in accordance with the method statement agreed with the EA and Veolia Water in order to demonstrate that the hydraulic containment system consisting of borehole BH28 is unnecessary.	May 2011 – June 2011 Contaminant analysis and Level logger monitoring until December 2011. (The trial may happen sooner dependant upon the results of the embankment borehole switch off trial.)	Schedule 1 Figure 6

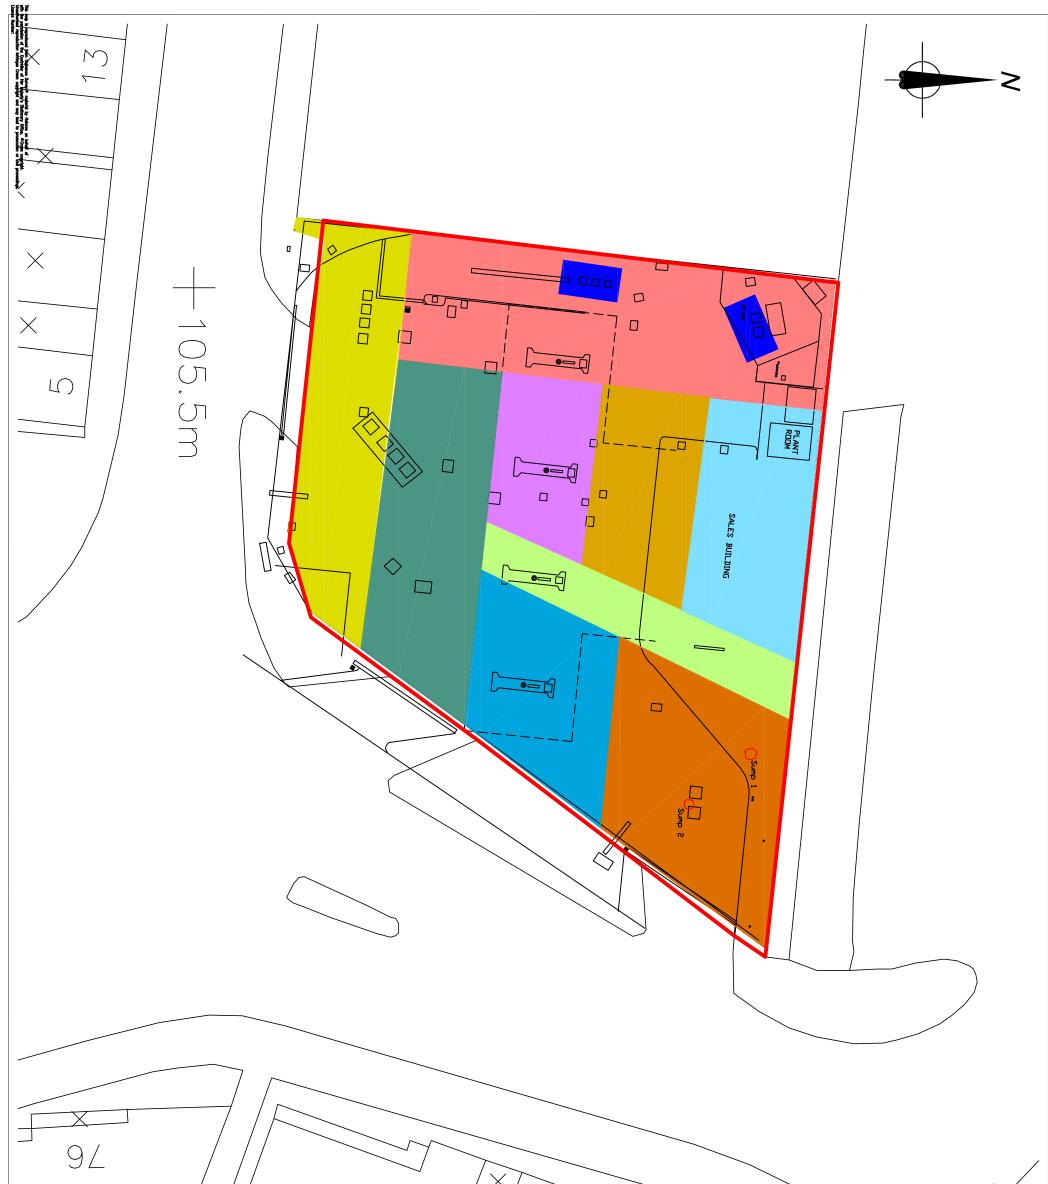
Drawn by: RML Date: Oct 10 Chedwart by: Date: - Approved by: Date: - Drawing No. Figure 5 Revision Drawing Scale: 12:500 at A3 Provide Manual Association	Notes1. Drawing information taken from the Celtic Drawing No. D1390/3809/A2 (19/03/10)Image: Drawing No. Day/3809/A2 (19/03/10)Image: Drawing No. Drawing No. Drawin	Key Plan:Extent of land designated as contaminated landExcavation Area 1Excavation Area 1Excavation Area 2Excavation Area 3Excavation Area 10

5.	1	Excavation of Made Ground and alluvial soils across the former petrol forecourt area and ex-situ bioremediation of hydrocarbon	December 2009 – April 2010	Schedule 1 Figure 5

impacted soils. Removal of all surface water	
drainage.

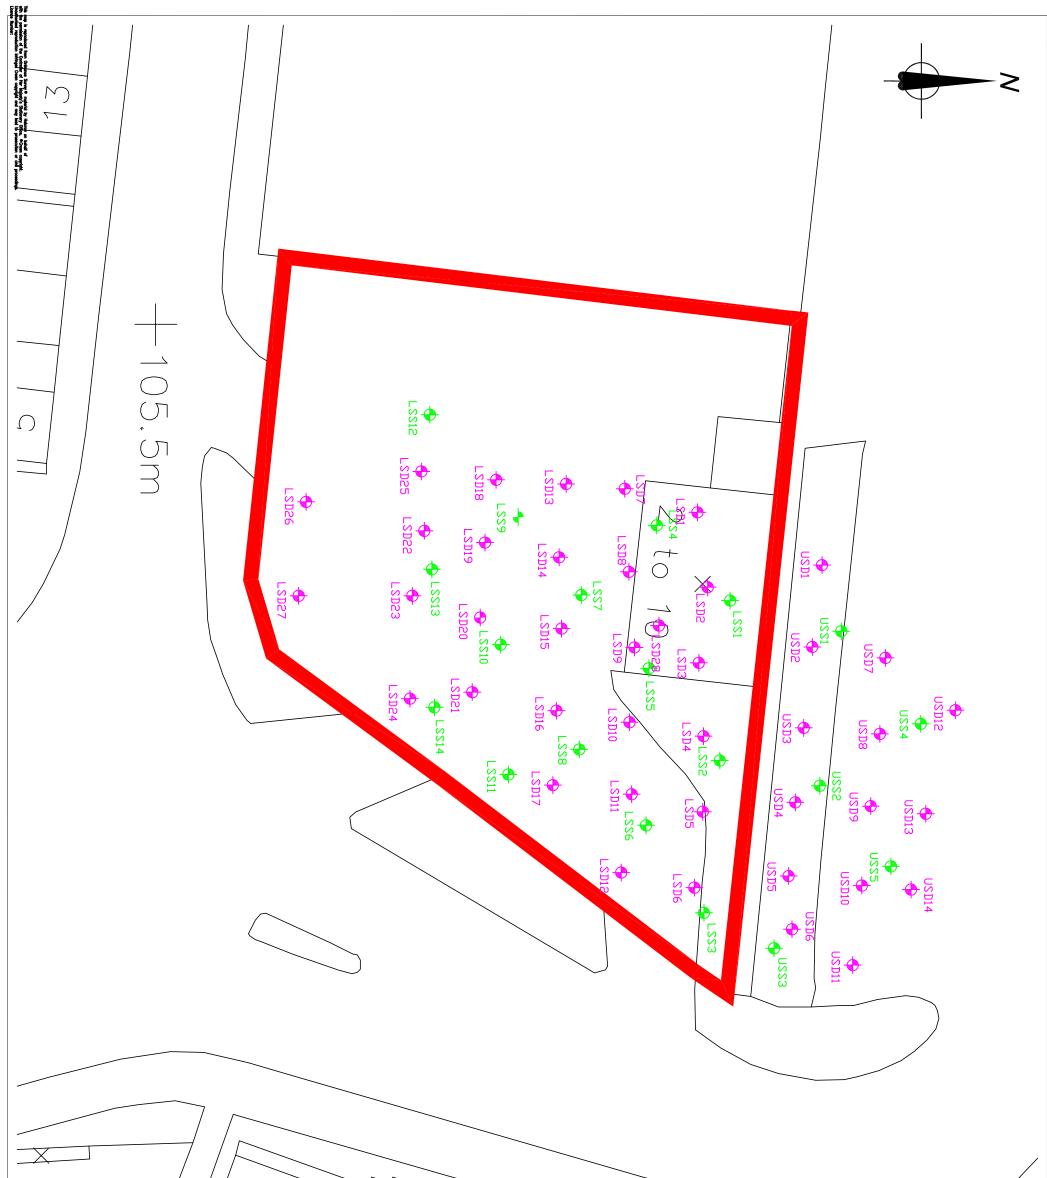
N N N N N N N N N N N N N N N N N N N		
Figure 4	Composition Markon Stranger Rearry on Bits Bit Tel 4 (1017) 401 1980 Markon Stranger Rearry on Bits Bit Tel 4 (1017) 401 1980 Markon Stranger Rearry on Bits Bit Tel 4 (1017) 401 1980 Markon Stranger Rearry on Bits Bit Tel 4 (1017) 401 1980 Markon Stranger Rearry on Bits Bit Tel 4 (1017) 401 1980 Markon Stranger Rearry on Bits Bits Bits Bits Bits Bits Bits Bits	Rev By Chid Approx Date Rev By Chid Approx Date Description	Notes 1. Drawing information taken from the Celtic Drawing No. D1390/3795/A19 (23/03/10)	 Key Plan: Extent of land designated as contaminated land ♦ Shallow Treatment Wells LSS7 (Celtic 2010) ♦ Deep Treatment Wells LSD26 (Celtic 2010)

2. Installation of Multi Phase extraction system to remove unleaded petrol contamination from Putty Chalk Strata	Demonstrated asymptotic recovery rates of mobile hydrocarbons.	1	Installation of treatment system to treat unleaded petrol contamination within the Putty Chalk strata within the petrol forecourt site and a portion of the adjacent Luton Borough Council owned car park	August 2010 – January 2011	Schedule 1 Figure 4

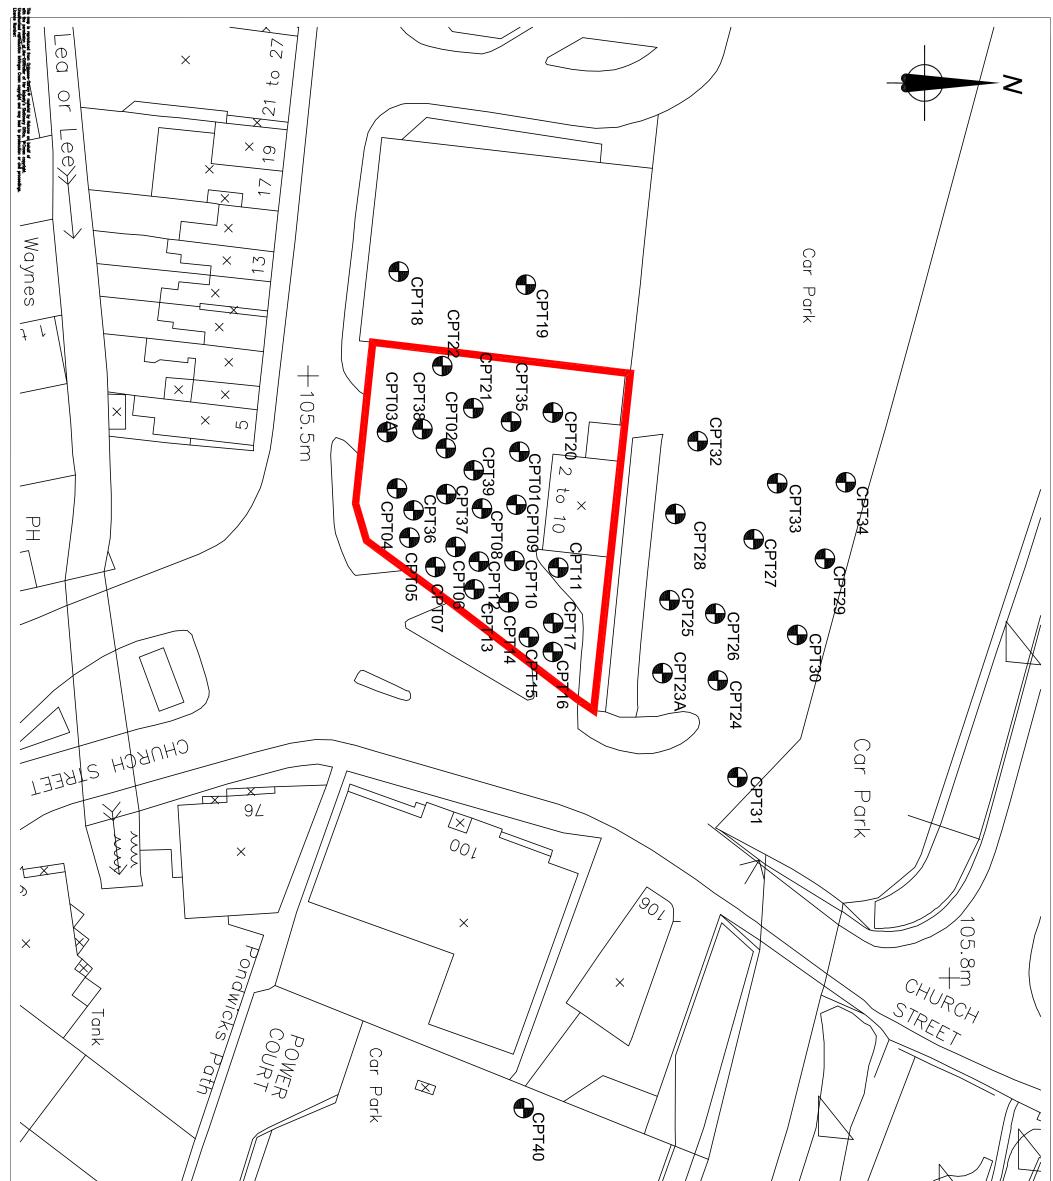
PRELIMINARY		
	Notes:	Key Plan: Extent of land designated as contaminated land CPT01 Halcrow 2009 (CPT01 to CPT40) Static Cone Penetration Testing locations with fuel fluorescence cone

1			
		6 no. boreholes into the Putty Chalk stratum to provide data on contamination within Putty Chalk stratum and for the purposes of ongoing monitoring.	December 2009	
5	1	Installation of 6 no. boreholes for the purposes of delineating the vertical profile of contamination within the Putty Chalk together with associated groundwater monitoring.	June 2009 – June 2010	Schedule 1 Figure 2
6	1	Cone penetration testing at 60 no. locations in order to assess the depth of penetration of unleaded petrol within the Putty Chalk and confirm lack of penetration into competent chalk strata.	June 2009	Schedule 1 Figure 3
