# Safety camera personal injury collision data

## Camera T21: Stuart Street outside law courts

**Author:** Passenger Transport Unit

**Last updated:** November 2018

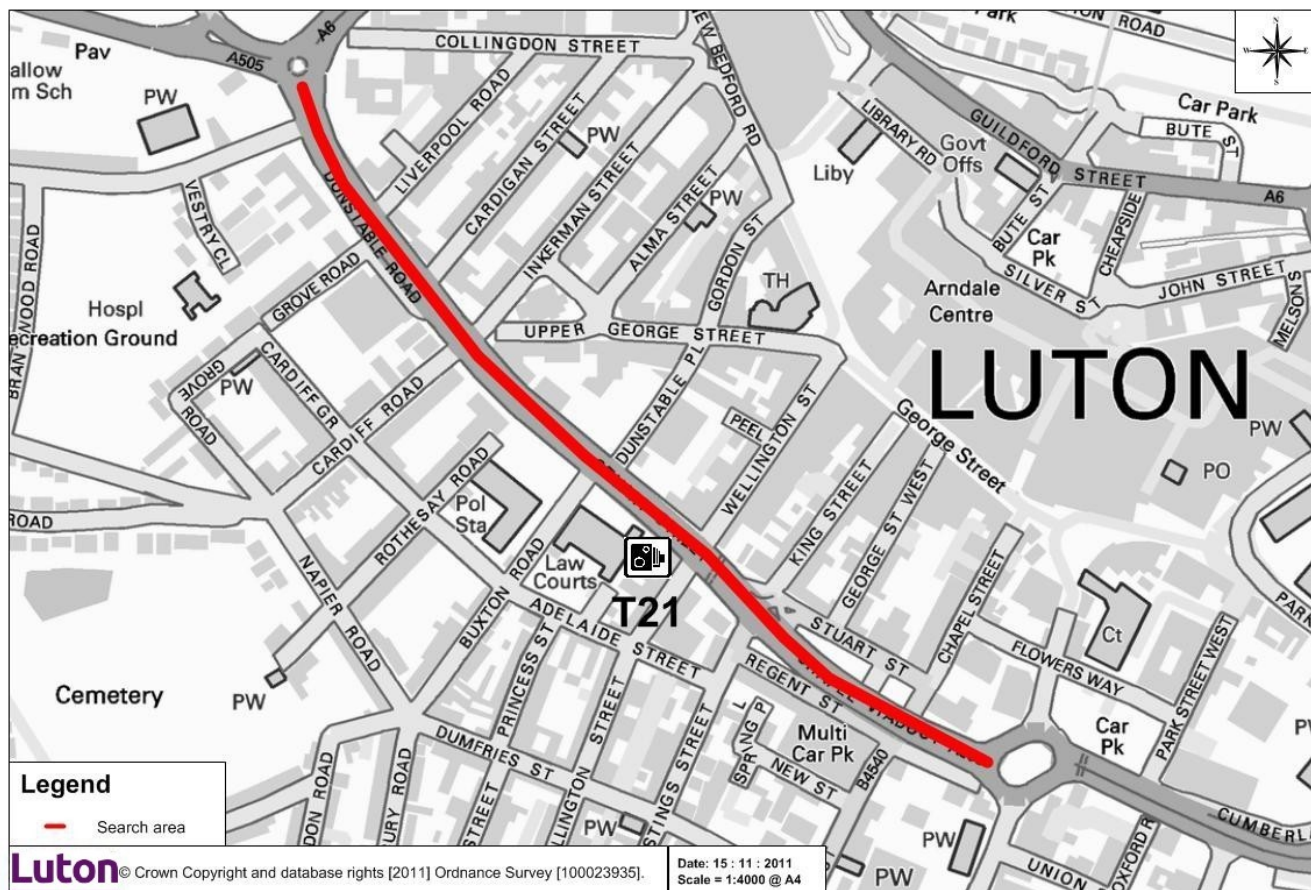
## Plan of site including search area

- **Location:** Stuart Street outside Law Courts
- **Site number:** T21 westbound
- **Camera coordinates:** 508909, 221141
- **Date established:** September 1998
- **Speed limit:** 30mph
