# PLAITERS' LEA CONSERVATION AREA, LUTON HISTORIC AREA ASSESSMENT

# PLAITERS' LEA CONSERVATION AREA LUTON

## HISTORIC AREA ASSESSMENT

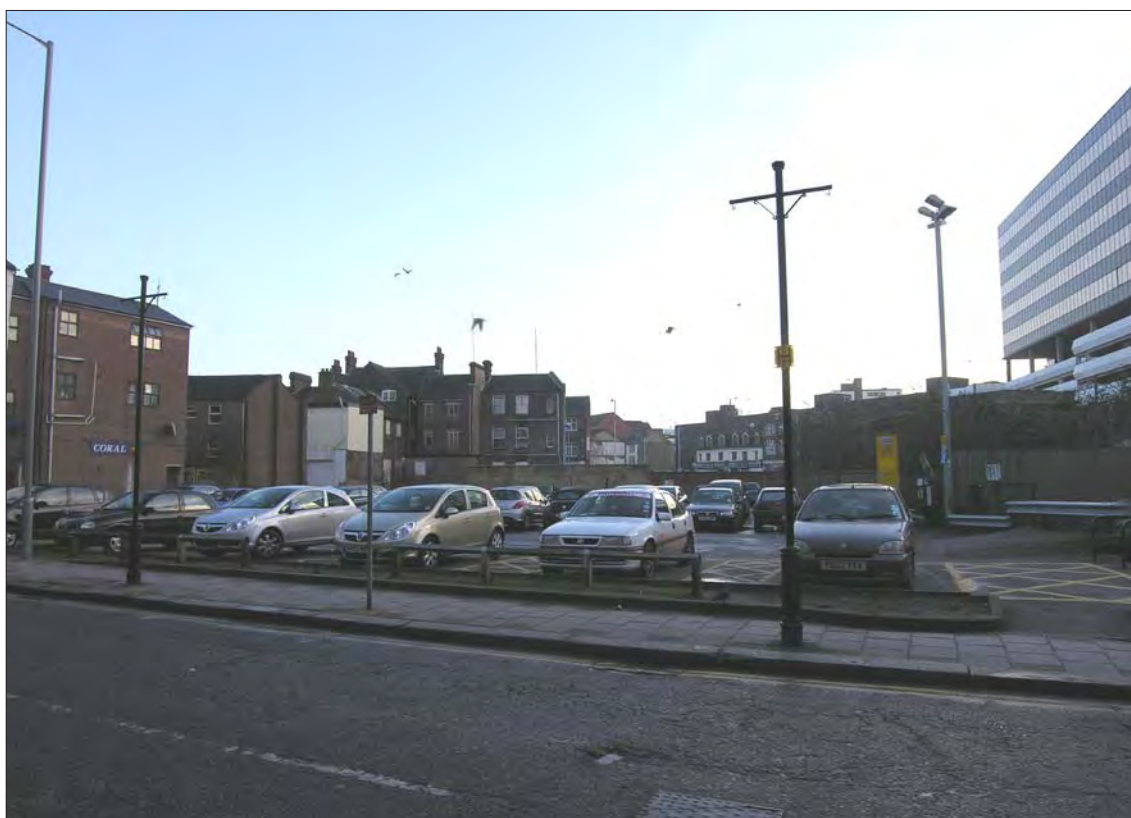
The street frontage within the Conservation Area is diverse, particularly at ground level, but is frequently interrupted by vacant plots and large open areas, now generally used as temporary car parks (Figure 28). Indeed, many buildings at the heart of Conservation Area have been demolished and replaced by car parks – building plots on the northern side of Silver Street (opposite the Arndale) are now used as temporary public car parks,

Figure 28. Vacant plots now used as temporary car parks at the heart of the Conservation Area.  
© David McOmish.

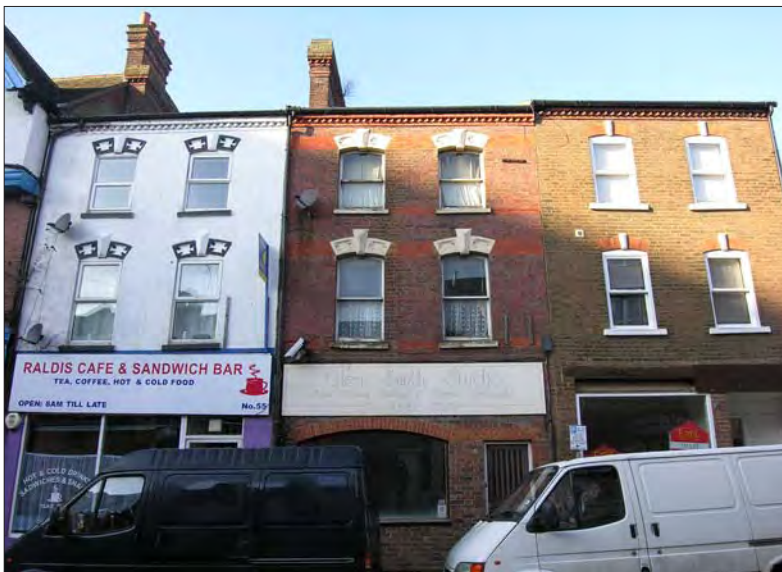
Figure 33. 55-59 Cheapside.  
© Katie Carmichael.

55-59 Cheapside is a three-storey terrace of three individual properties. Built prior to 1880, they feature sawtooth detailing immediately below the eaves and to the tops of the chimney stacks, whilst 55 and 57 have a Maltese cross style motif within the stone window heads. The ground floors of the properties have been substantially altered but it is likely that they originally contained shop windows (Figure 33).

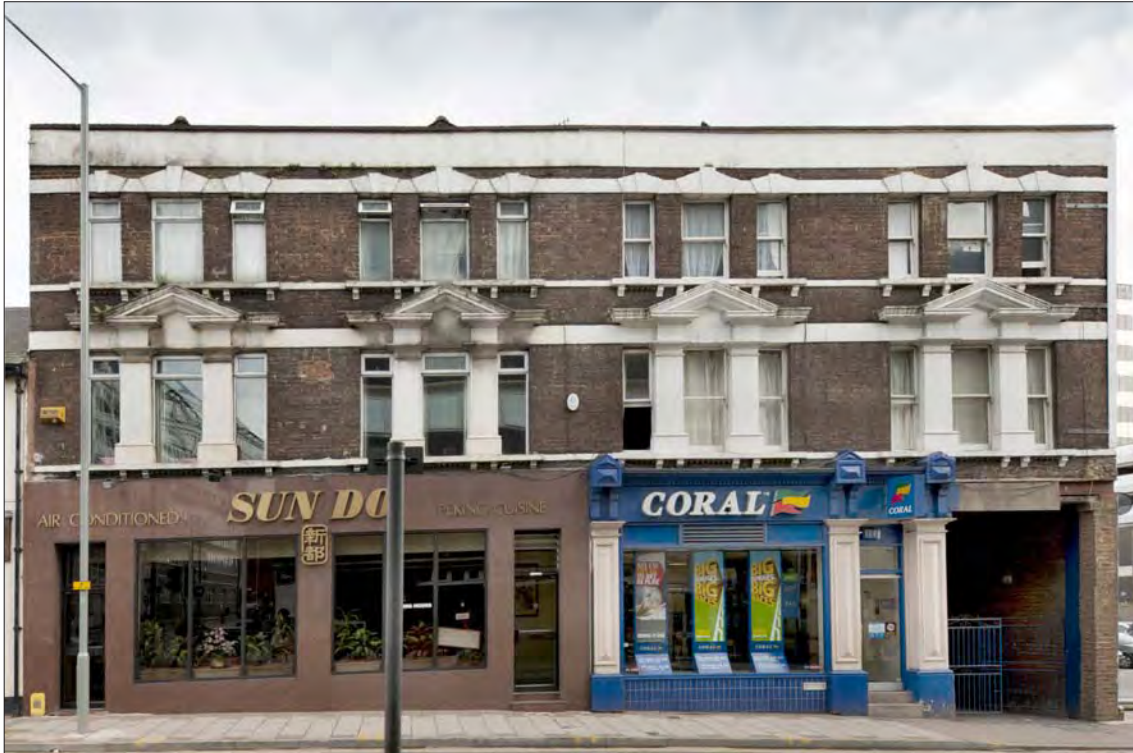
Figure 34. 50-54 Bute Street.

The terrace of four properties at 50-54 Bute Street appears to have been erected in the late 1870s and is an example of speculative commercial development (Figure 34). The bold treatment of the first-floor windows is unique in the area, the triple lights with bracketed sills being divided by heavy pilasters which support a broken pediment. The dark brick of the building contrasts strongly with the white painted rendering of the window surrounds, bands and pediment, creating a noteworthy façade.

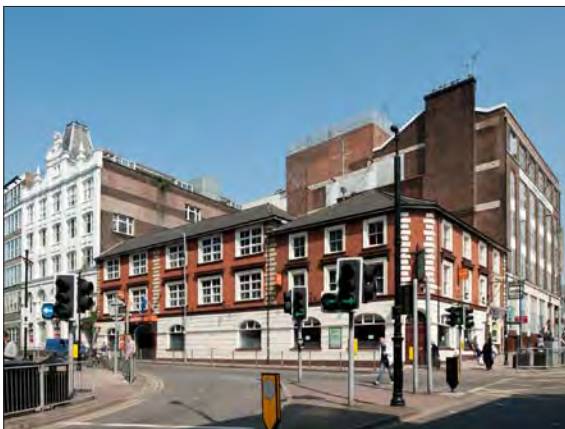
Figure 36. The easyHotel. © English Heritage NMR DPI41936.

A number of businesses combined domestic and commercial elements to form an eclectic local vernacular style. One such example is 61 Bute Street, now the ‘easyHotel’, which was built in the 1860s (Figure 36). Here, rusticated stucco has been used to great effect on the ground floor of the building, whilst yellow brick quoins to the first and second floors further enliven the façade. The sash windows are all surrounded by architraves, the first-floor windows surmounted by moulded brick cornices on consoles – lending a somewhat domestic air to the property. In contrast, 36 Guildford Street sits in a prominent location close the intersection of Bute Street and Guildford Street and its most notable feature is the use of white, banded, rustication in conjunction with a half basement and raised ground-floor wholesale showroom – possibly the earliest occurrence of this in the Conservation Area (Figure 37). The provision of two doors mirrors the arrangement at many other similar properties in the Conservation Area: one providing access to the showroom, the other leading to workshops. The particular style and arrangement of the fenestration, containing large paned sash windows without horns, suggests a date of around 1860-70 and is similar to that seen on other buildings within the area, such as 15 Guildford Street. Indeed, the use and treatment of the rustication is another feature which appears repeatedly within the Conservation Area and on buildings of almost every period.

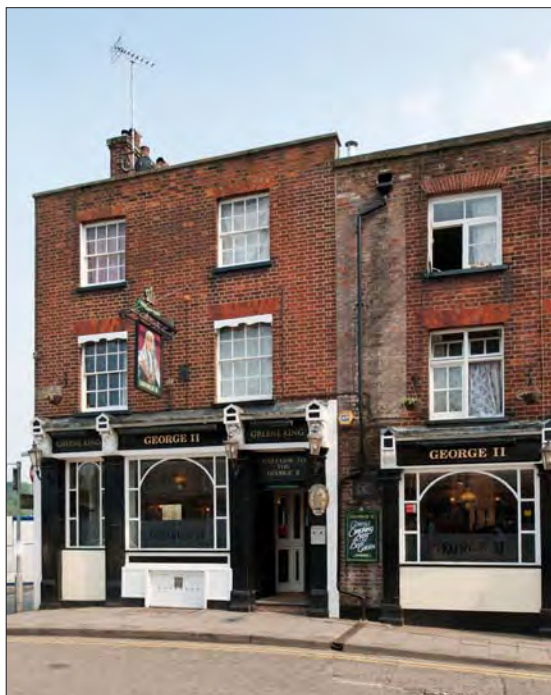
Figure 42. 'The Engine' public house.  
© English Heritage NMR DPI41916.

A number of new public houses opened near the station around 1870, including 'The Engine', at 43 Bute Street, which was originally built in 1865 but burned down and rebuilt in its current form in 1900 according to an inscription on the gable (Figures 41 and 42). The building is notable for its use of polychromatic brickwork – the Bute Street elevation built using Luton Stock grey bricks with decorative banding, whilst the southern elevation is built in yellow brick with red brick banding. However, many of the features, such as the polychromatic brickwork, segmental window heads and the low relief stencilling in the tympanum above the central window, would suggest a date of c.1865 – therefore the precise extent of the turn-of-the-century rebuilding remains uncertain. Opposite, on the eastern side of Bute Street, was another pub called 'The Empress' built over the river Lea – as previously mentioned this was demolished and only fragments remain visible within the north wall of the conduit.

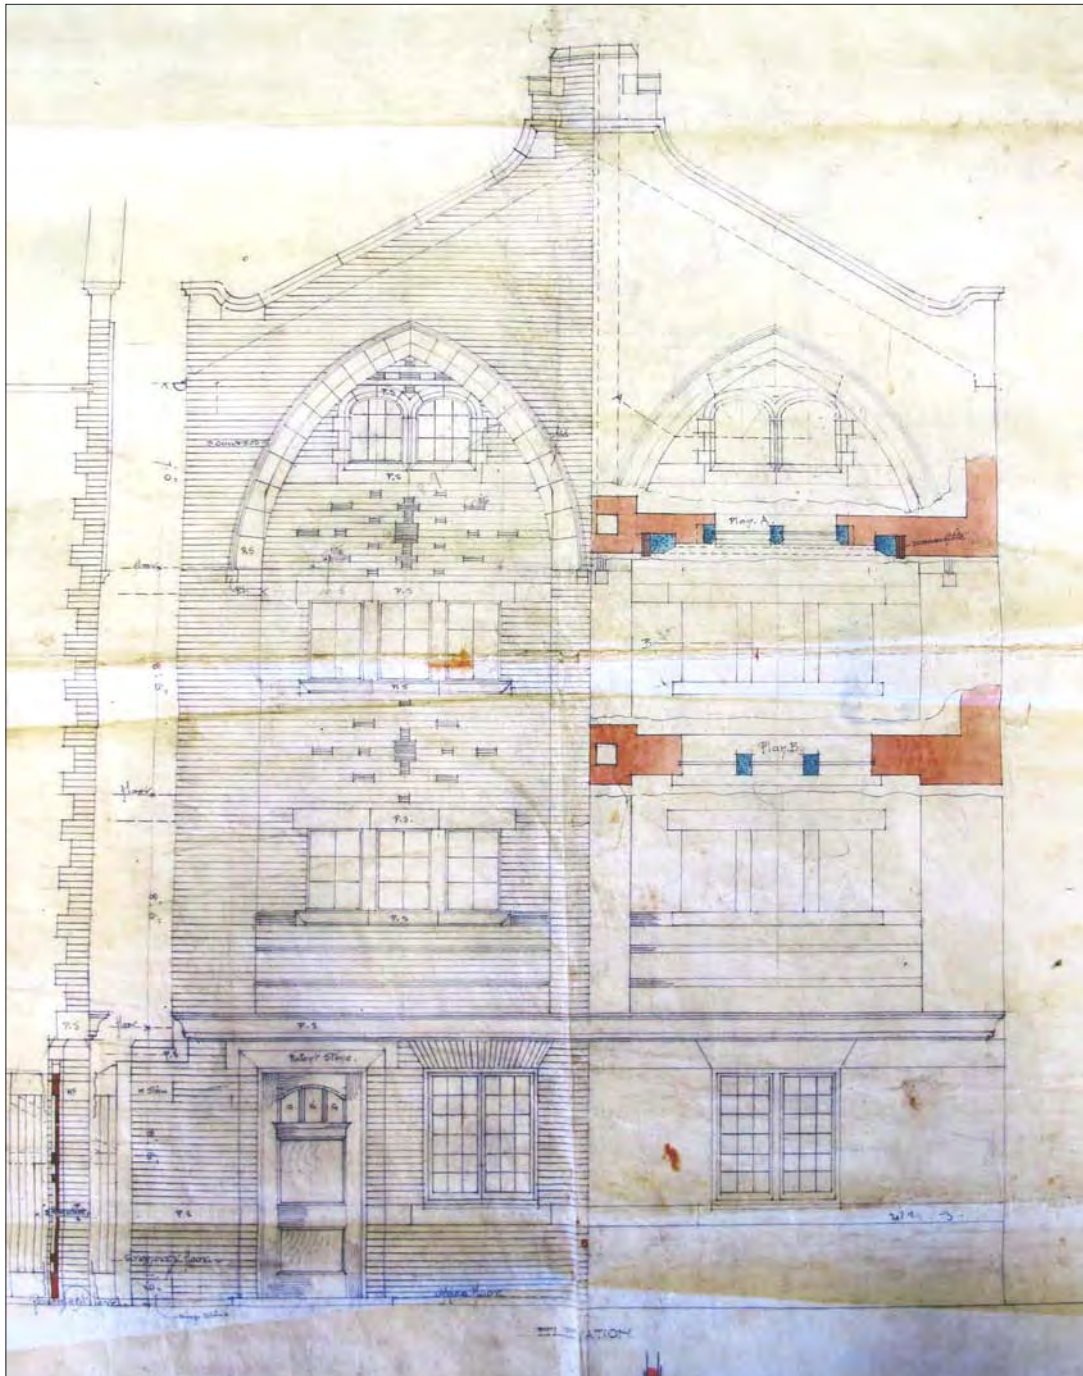
long-established in Luton. The former corn warehouse at 55 John Street is an intriguingly late example of gothic revival design, built for Tomson & Sons corn merchants in c.1913.<sup>133</sup> Built using pier and panel construction, the four storey building is dominated by giant order pointed arches springing from the piers to encompass the windows. It has been constructed using a mixture of Luton stock and red brick with concrete details, the panels incorporate decorative tiles which hint at the influence of the arts and crafts movement. Plans for the property drawn up in 1912 by the architect Max Zimmermann (Figure 62) show how well the John Street elevation has survived.

Figure 62. Plans for a new granary on John Street by the architect Max Zimmermann, dated 1912.  
BRO X843/1168(1)

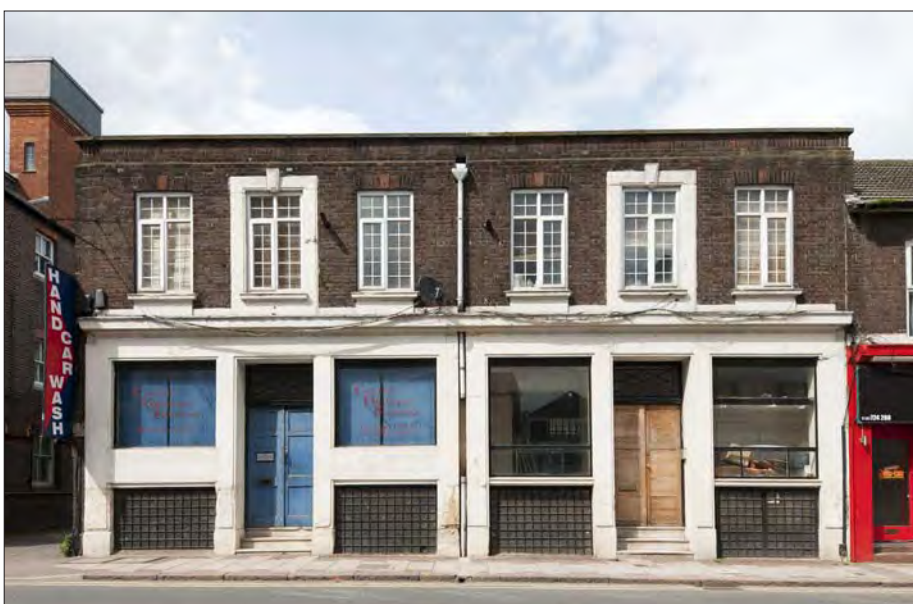
Figure 71. 22a-b Guildford Street.  
© English Heritage NMR DPI46064.

A more conventional example of the Neo-Georgian style that was current in the early 1930s can be seen at 22a&b Guildford Street (Figure 71). This is a small symmetrical pair of premises, two and a half storeys high, of red brick, with a flat roof hidden behind a soldier-course parapet. The commercial function is betrayed by the treatment of the ground floors: each property has a central doorway, reached via steps spanning the basement and flanked by two display windows. These have smooth rendered surrounds, not the banded rustication favoured elsewhere throughout this district. The panelled double doors and fine transom lights survive. Above this, the first-floor windows contain casements, and in each case the central one is emphasised by a broad, rendered frame with a prominent keystone. Building control plans for the building shows that it was designed by B.B. Franklin in November 1931 and approved in January 1932

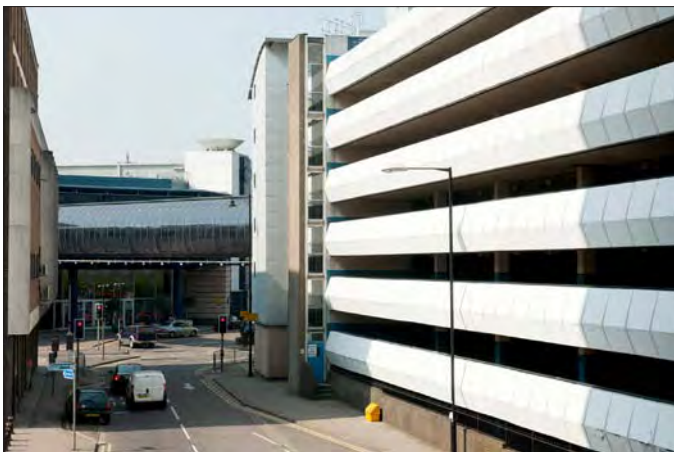
The Library Theatre car park is a six storey car park built in early 1970s and now closed and earmarked for demolition (Figure 75). The heavily modelled v-shaped GRP balustrades to each of the floors impart a powerful horizontality, punctuated by projecting stair towers, which are glazed on the returns and display deeply incised vertical lines on the elevations facing the street. Overall it is a powerful composition compromised by a dwarf brick wall surmounted by equally incongruous, municipal style and rather fussy railings in front of it at pavement level.

Figure 75. View of the rear of the Library Theatre car park. © Katie Carmichael.

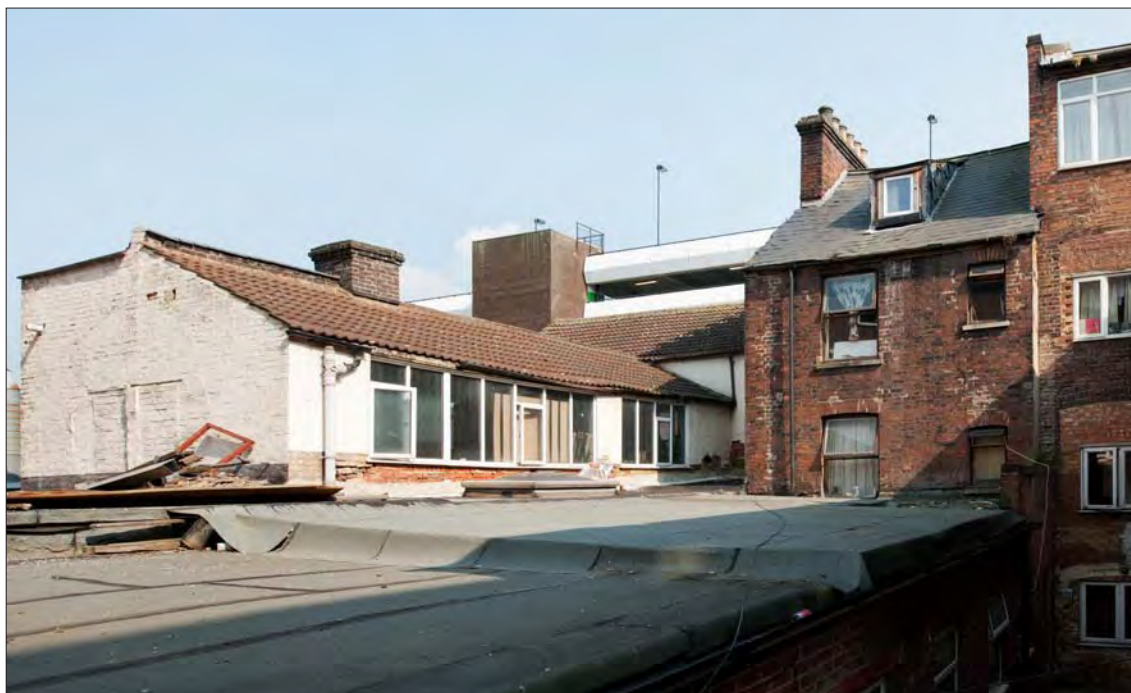
Despite the designation of Conservation Area status and the stated aim to maintain Plaiters’ Lea’s historic role within the proposed ‘Northern Gateway’ development, there are clearly a number of older properties that are currently at risk either from further decay or from insensitive alterations. This, in part, is due to the difficulties that arise in effectively ‘policing’ Conservation Areas but also reflects a lack of appreciation of the area amongst individual property owners and landlords. A particular focus for concern are the properties at 49-51 Cheapside and 29-31 Guildford Street and especially what remains of Melson Street where immediate attention is required. An alarming state of decay is apparent on certain street frontages and is even worse at the rear of the properties where crumbling brickwork and roofs in a state of near collapse are evident.

Figure 86. Buildings in a poor state on Melson Street
